Article

The Stabilization of a Hellenistic City Square (Plaza) at the Kınık Höyük Archeological Site, Niğde Province, Türkiye

Keywords: Hellenistic Plaza; cobblestone floor; consolidation; eco-pozzolan

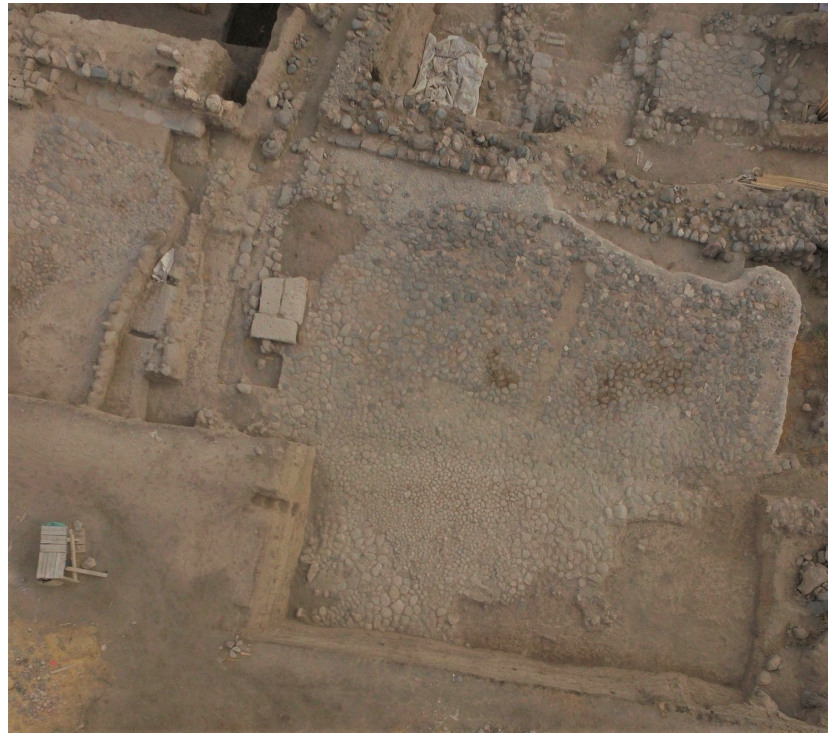
The ongoing excavations have shown that religious life at Kınık Höyük in the Hellenistic period was centered around an open space, the plaza (Figure 1). The great plaza was paved with stones and located at the northern edge of the town's citadel.

Figure 1. Drone photograph of the plaza, 2022.

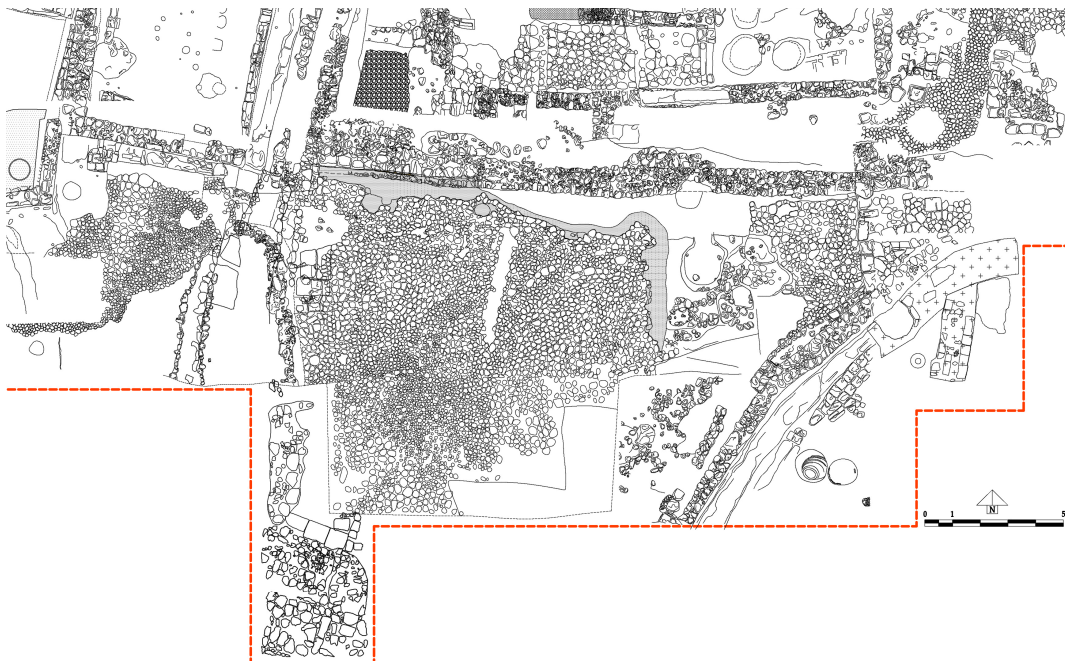
Figure 2. Topographic survey of the plaza, 2022 (Red, dashed line indicates the border of the related year's investigation).

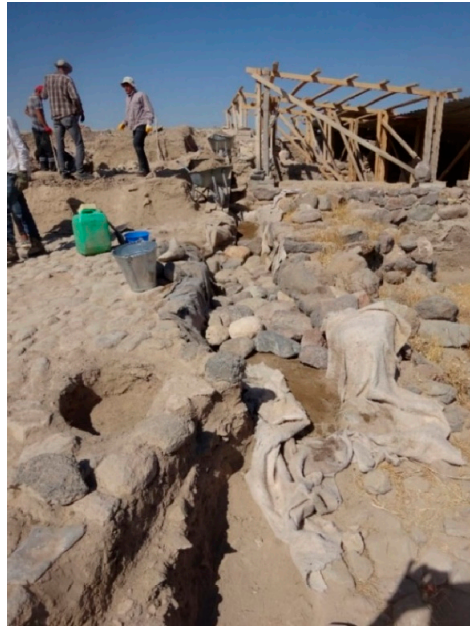
The floor in question at Kınık Höyük was built over a surface at an average elevation of 1214.80 m asl. A deep trench discovered in a portion of the floor exposed a section of the layers under the floor. To provide a stable foundation for construction, a muddy compact make-up layer of soil was first applied, or the existing ground was firmly compacted. On top of it, there was a chipped-stone preparation layer, consisting of broken limestone chips of about a 2 cm thickness. It seems that this sub-floor was designed to ensure proper water penetration and to address surface leveling issues. Consistent with the flooring traditions documented in the literature, these aspects made for a flexible and permeable paving surface. Above the limestone chips, a sandy soil layer of 15 cm served as an embedment for the cobblestones and allowed water to percolate and avoided paddles and/or damage to the floor. Over this sandy bed, the stone pavement consisted of cobblestone. The surface sizes of these round flat paving stones range widely, from 10 to 40 cm, and they are typically buried in the earth at no less than 5 and 6 cm deep. The stones present different shades of black, white, yellow, and pink and alternate between soft and hard textures. The original stabilization of the flooring at its construction was enhanced by compacting earth

between adjacent stones, a so-called interstice mortar. Figures 4 and 5 shows how they appear and Figure 6, Section A entails an approximate representation of these original construction layers.

Figure 4. Initial layers, geotextile and boulders, Section A.

The free edges in Section A (Figure 3) were only about 50 cm from an opposite stone wall, resulting in there not being enough working space to build a retaining wall. Hence, the main repair in this area consisted of filling the gap with suitable materials and cladding the surface. The opposite stone provided the edge's limit for this infilling action, and it might very well have functioned as the original edge of the pavement in antiquity as well. The required dimensions of this intervention were approximately a 6 m length, a 4 square meter surface area, and a 50 cm infill depth, as diagrammatically shown in Figure 6, Section A. The initial step of the conservation was laying a geotextile fabric cloth at the bottom of the infill to ensure complete separation between the ancient layers and the recent interventions. Over this cloth were piled up, layer by layer, soil, stones, mortar, and stray ceramic sherds found in earlier excavation seasons, as dimensionally documented in Section A of Figure 6. River stones, measuring no more than 10 cm, were ultimately used to cover these strata (Figures 4 and 5). The main infilling involved stacking boulders that were between 15 and 20 cm in size to provide a solid and leveled foundation for the new compacted earth layer. The original application's concepts were then repeated using sherds and earth infills, and paving was added as the finishing touch.

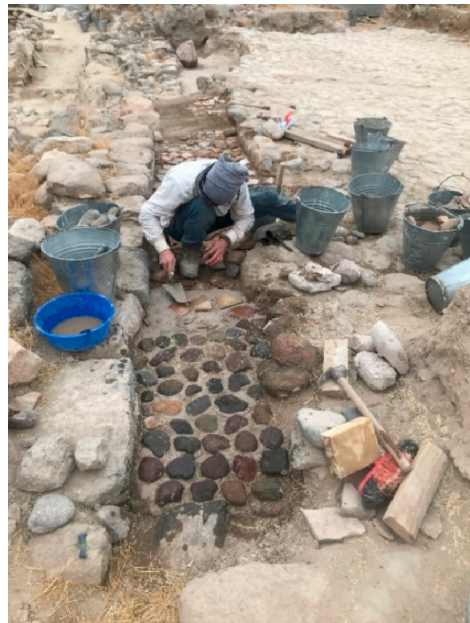
Figure 5. Infilling and cladding, Section A.

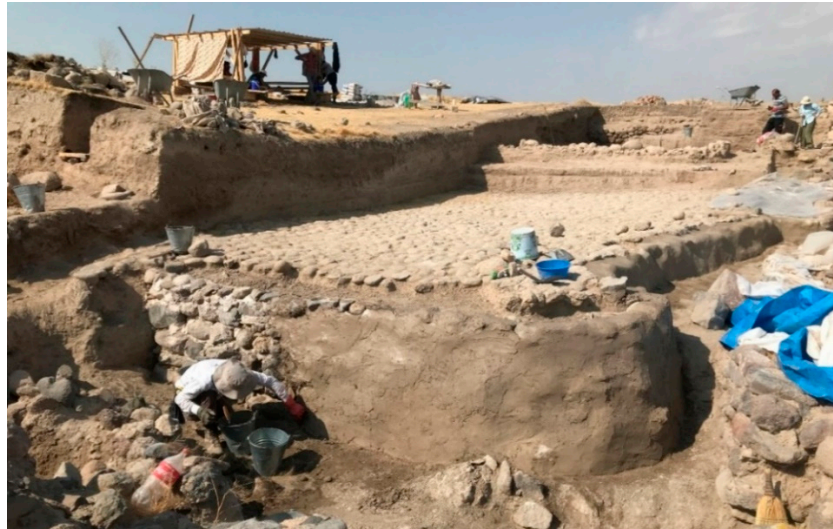
In accordance with the floor conservation process, a geotextile fabric cloth was employed during the retaining wall construction in Sections B and C to differentiate between the original layers and the contemporary interventions. After construction, the wall was completely plastered over, as designed initially (Figure 7). Soil from the site was added to the mixture of the plaster, which contained 1.5 units of binder (MAPE-ANTIQUÉ F21), 1 unit of 5 mm crushed basalt, 1 unit of basalt dust, 1 unit of 2 mm river sand, 1 unit of earth, 0.5 units of straw, and 1.5 units of water.

Figure 7. Construction of the retaining wall and plastering process.

The entire application process was realized in about two weeks with the active participation of the design team (i.e., the restorer and architect) and three experienced local workers, who worked under the direct guidance of the field archeologists. The implementation phase was conducted according to the principal planning details, and it was finalized without any further problems.

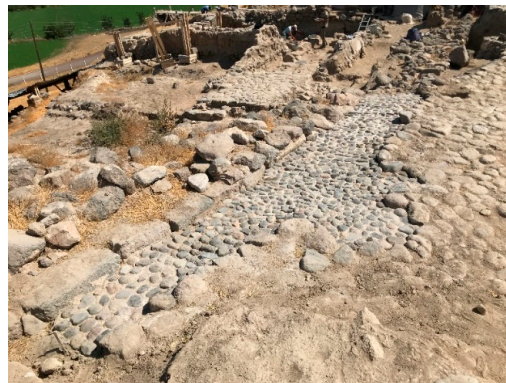
The application resulted in a final product that met the design goals visually. The unit material sizes, the surface levels, and the introduction of plaster all helped to satisfactorily ensure the ability to distinguish between the ancient remains and the recent interventions, as shown in Figures 8 and 9.

Figure 8. Section A after conservation.

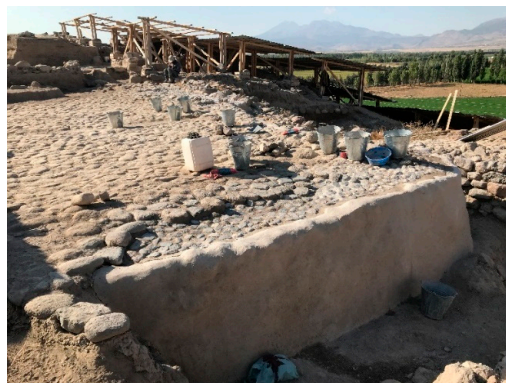
Figure 9. Section C after conservation.

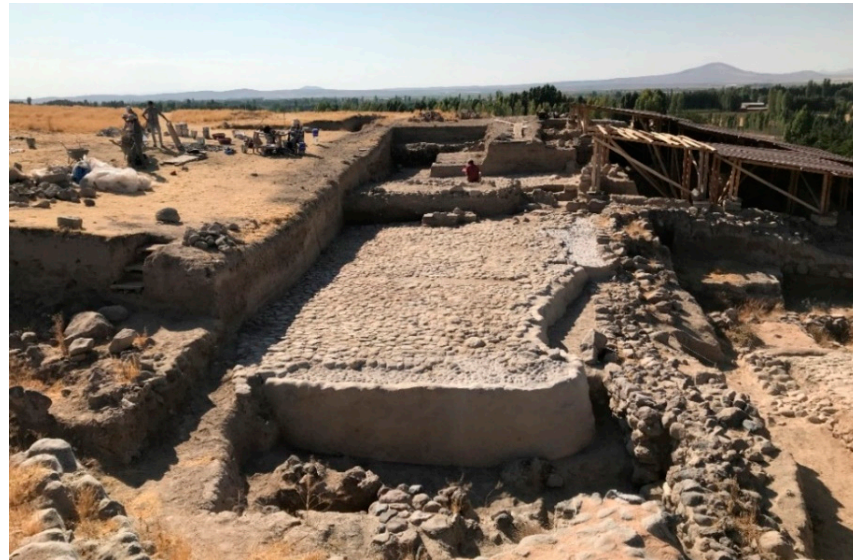
unbound edges provided evidence of a satisfactory mechanical level having been reached. The condition of the conserved area was in general successful, apart from two observable issues, as shown in Figure 10. The first one was the final color of the plaster on the retaining wall, which turned out to be more grayish than expected. The aim was to mimic the color of the local soil, but the preponderant use of gray hydraulic lime mortar to ensure the stability of the wall clearly affected the final appearance.

Figure 10. The Hellenistic Plaza after restoration in 2020.

This indicates that the amount of soil within the plaster mixture needs to be increased if color matching solutions are sought for future interventions. However, while this change in ratio will likely solve any issue of color matching, it will probably cause cracking or spalling due to the lack of binder in the plaster mixture. Therefore, further fine assessments for a mortar mixture exactly compatible with this kind of repair will need to be conducted in the event of future interventions.

The other observed issue is the accumulation of water in some areas of the new cladding. The reason behind this accumulation rests in minor workmanship errors and slight initial settlements, which are to be expected. Thanks to the permeability of the applied pavement technique, as well as the mortar itself, these small accumulations were not assessed as risky.

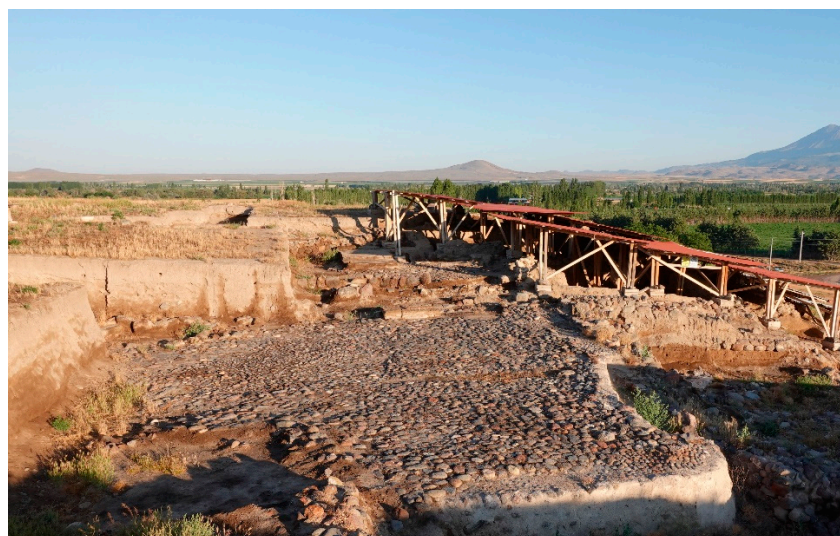
Three years later, in the 2023 season, after removing small plants that had grown within the interstice mortar, an initial visual assessment showed that the original pavement and the recent additions had withstood harsh seasonal changes (Figure 11). Even the color of the plaster had a more buff appearance when compared to the grayer color after the initial drying, and this resulted in a closer approximation to what the original design expectations had been. Excavations continued in areas all around the plaza, meaning that besides weathering, the intervention could also withhold pedestrian traffic and working activity. The visibility of the monuments to visitors is also an additional value of the intervention.

Further investigations revealed a certain degree of spalling of the mortar and some detachment of the cobblestones in some areas of the repaired portions. Although these spots were easily repaired following the same techniques employed during the previous year, these instances revealed the need to reconsider the ratio of material adopted in the mortar composition. These investigations are ongoing and involve consultations with chemical engineers that specialize in historical mortars. The results of any changes or upgrades in upcoming conservation strategies, materials, and implementations will be shared in future contributions.

Figure 11. The plaza three years after consolidation, in 2023.
