Landslides (2018) 15:199–217
 DOI 10.1007/s10346-017-0865-0
 Received: 11 January 2017
 Accepted: 14 July 2017
 Published online: 1 August 2017
 © The Author(s) 2017
 This article is an open access publication

A multidisciplinary approach for the investigation of a rock spreading on an urban slope

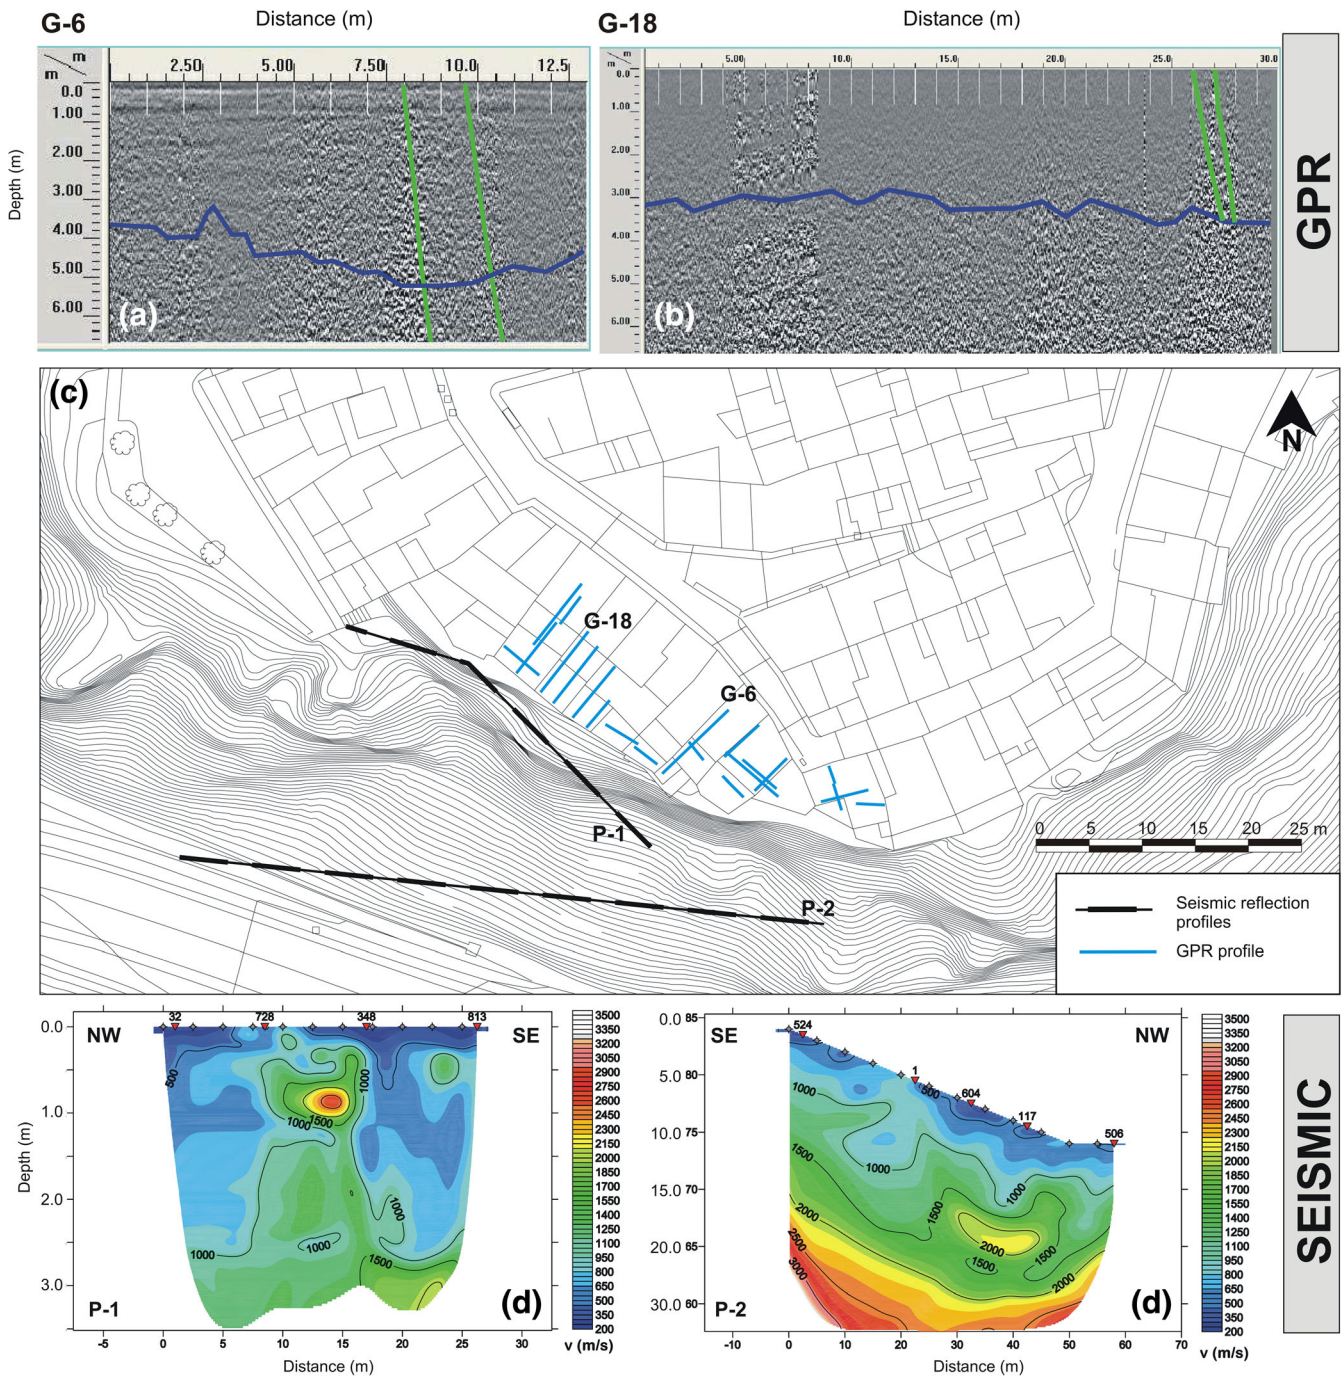
Fig. 4 a, b G-6 and G-18 ground penetrating radar profiles. Blue lines represent the top of the massive gypsum subunit (T2) and green lines the earth fissures. c Location of the ground penetrating radar and seismic refraction profiles. Note that although the figure represents the 16 GPR transects performed, only profiles G-6 and G-18 are shown as examples. d, e Seismic refraction profiles made on and along the slope. Notice that the vertical and horizontal scales of P-1 and P-2 profiles are different in both plots

GPR continuous graphic profiles were recorded using a GSSI SIR-20 data acquisition system coupled to an antenna with a frequency of 200 MHz. The profiles were conducted on 16 linear sections located on the ground floor of the damaged buildings located on the crown of the slope (i.e. on the top of the massive gypsum subunit, T_2) and post-processed to enable the interpretation of the existing features. The depth of the GPR survey covers the upper 6 m of depth as the main aim was to locate the earth fissures affecting the more surficial layers. The results show that the depth of the less stiff materials (i.e. artificial filling, ml_1 , and weathered massive gypsum) reaches depths from 1.5 to 5.0 m (Fig. 4). Moreover, the GPR profiles have allowed the recognition of different earth fissures with depths varying from 2 to 4 m. The depth of these cracks reaches maximum values near profile G-6 of 4 m gradually decreasing towards the eastern and western ends.

Furthermore, the correlation of the different GPR profiles has allowed delineation of the direction of the main earth fissure affecting the buildings that varies from N109E to N130E.

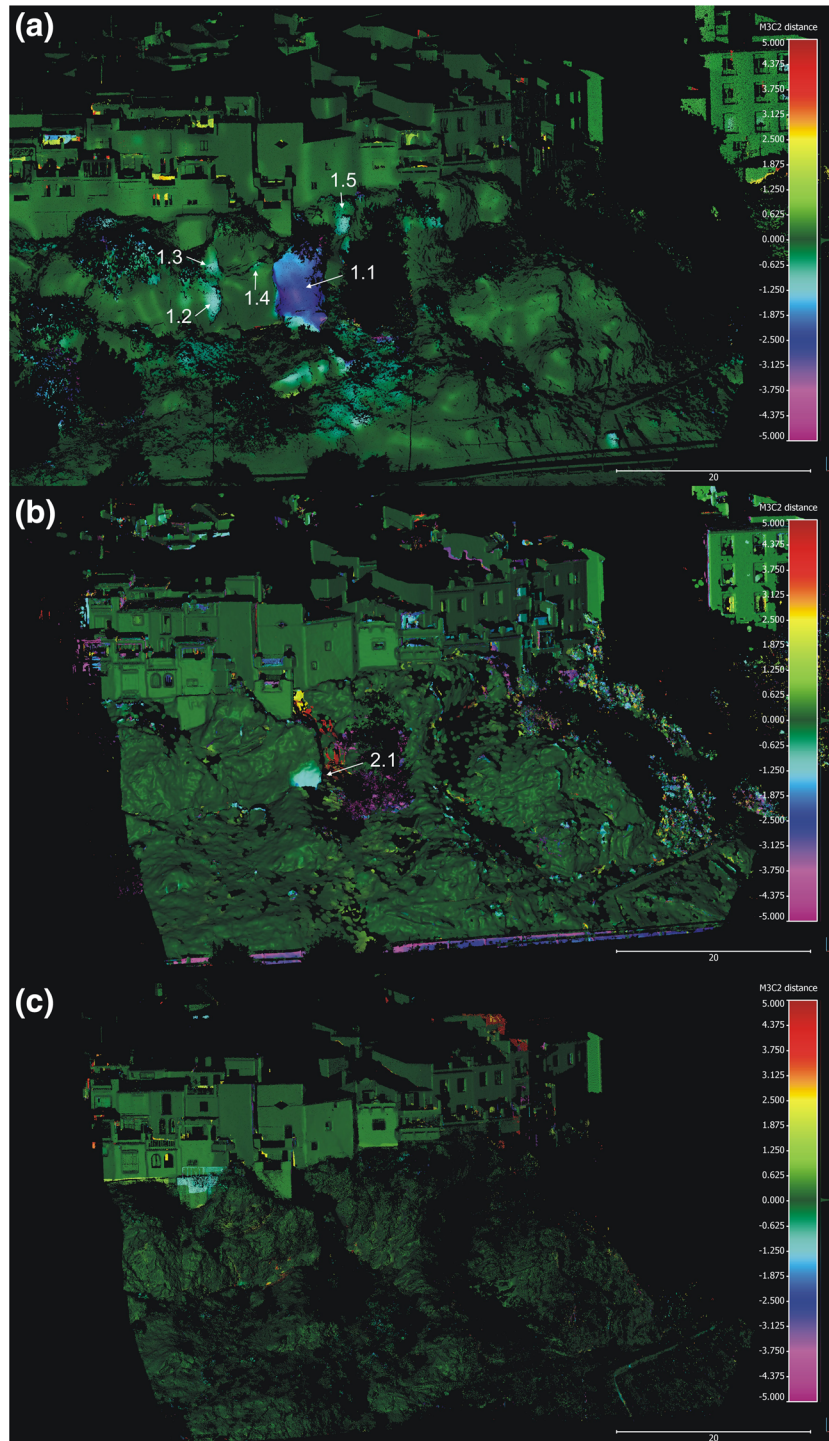
Fig. 6 Comparison of LiDAR models showing large-scale changes corresponding to **a** February 2011 vs. August 2012, **b** August 2012 vs. July 2014 and **c** July 2014 vs. January 2016. The labels indicate the rockfall events detected for each period. Note that the two last images only cover the easternmost sector of the slope since the 2014 3DPC was only acquired for the study of the buildings placed on this sector

The changes not labelled in Fig. 6 are associated with outliers that generate isolated changes, man-made modifications (e.g. the anchored reinforced concrete capping beam built between 2014

and 2016 on the top of the slope; Fig. 6c) and vegetation phenology (mainly affecting the results shown in Fig. 6a, b, due to the strong clearing and pruning works performed during these periods).

periods 2011–2012 and 2011–2014 are near 15 cm, being slightly higher in the upper part of the slope and the lower part of the buildings (Figs. 3, 6 and 7). Notice that, as the inclinometer S-1 is placed on the back of the rock block delimited by the main earth fissure (Figs. 1 and 3), its displacements are lower than those measured by means of TLS data on the slope face and the

the area has been affected by sagging accompanied by the horizontal displacements measured by TLS and the inclinometer and observed in Fig. 6d.

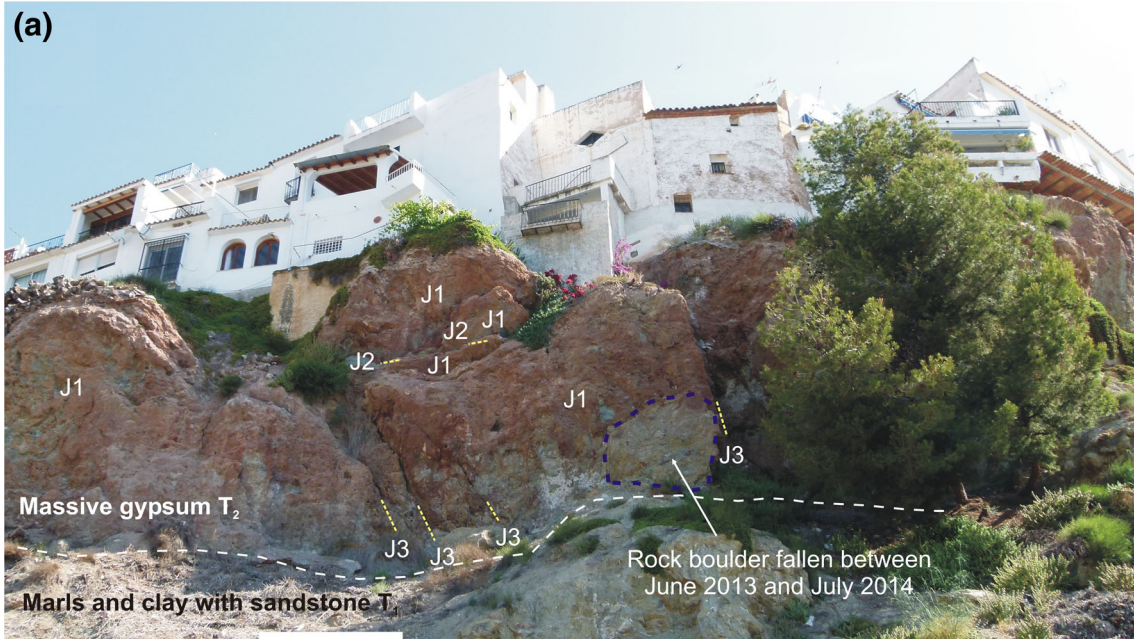
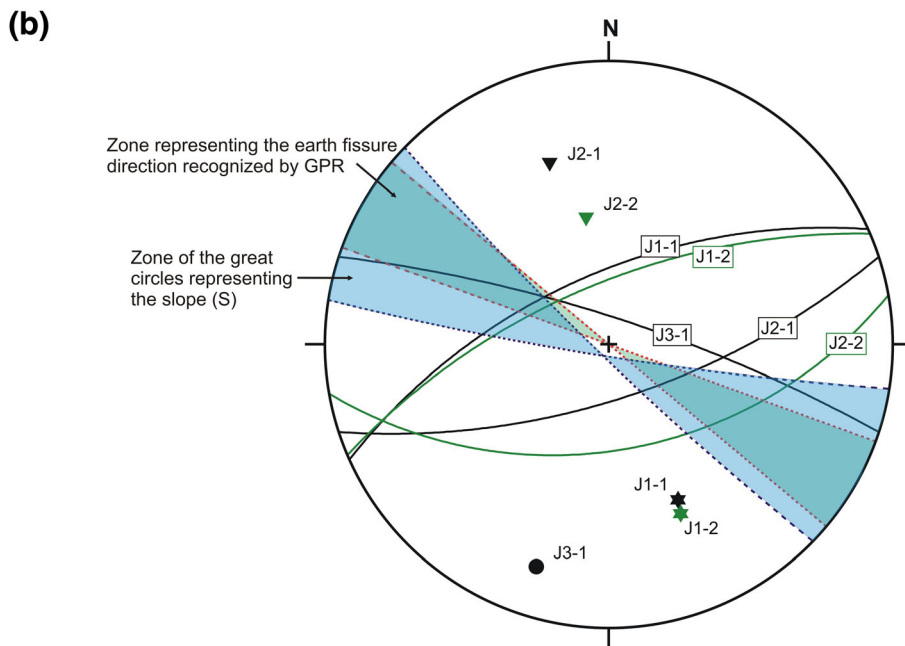
Fig. 9 **a** Location of the discontinuity sets J1, J2 and J3 affecting unit T2 semi-automatically derived from LiDAR 3DPCs. *Dashed line* maps the contact between the massive gypsum (T2) and the marl and clay (T1) subunits and *dotted line* delineates the rock block fallen between June 2013 and July 2014. Pictures were taken on June 2013. **b** Stereonet representing the poles and great circles of the discontinuities derived from the 3DPC and the zones of the great circles representing the earth fissure recognized by GPR and the slope. *Black* (J1-1, J2-1 and J3-1) and *green* (J1-2 and J2-2) poles were derived from the 2011 and 2012 scans, respectively

Figure 9b represents the stereographic projection of the different discontinuity sets derived from the analysed 3DPCs (J₁, J₂ and J₃) as well as the zone of the great circles representing the variability of the slope (S) direction. The zone representing the range of directions of the earth fissure recognized by means of the GPR technique is also represented in the plot. From the figure, it is clear that J₁ (the most exposed discontinuity) and J₃ present a similar subvertical dip value and dip into the slope being geometrically compatible with a toppling failure mode. On the other hand, discontinuity set J₂ dips out of the slope with a variable dip between 49 and 68° being prone to planar failure. It is noteworthy that the orientation of J₃ obtained using LiDAR 3DPC is very similar to that derived from GPR results for the main earth fissure affecting the buildings (Fig. 8b).

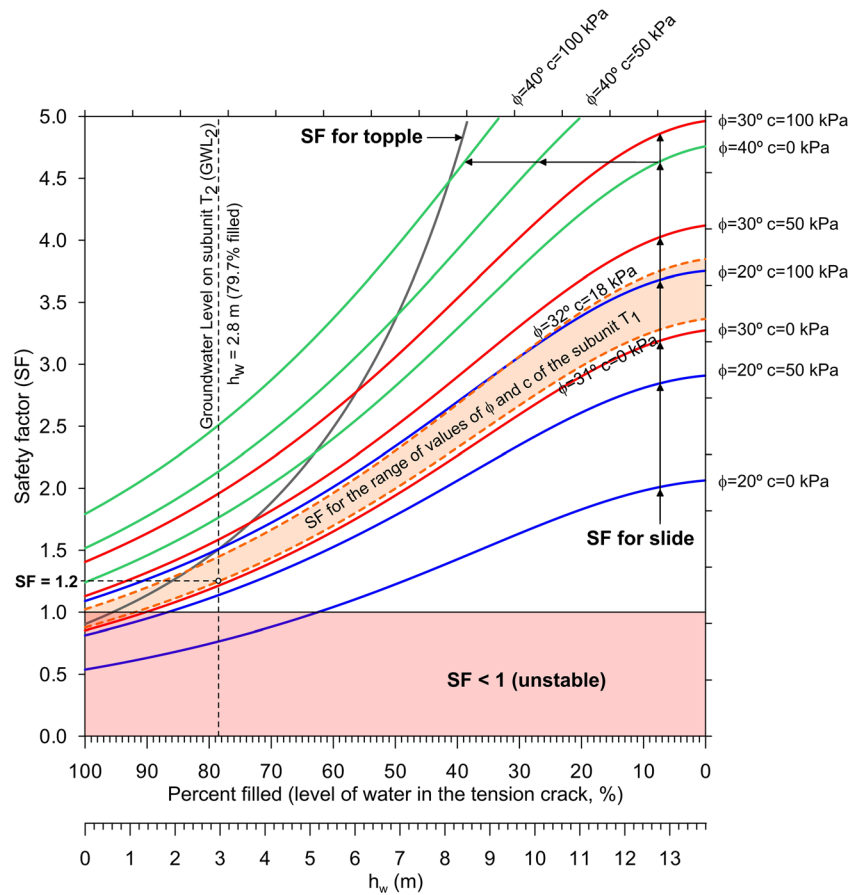
Fig. 13 Summary of the values of the safety factors of the slope obtained from the performed sensitivity analysis considering toppling and planar failure modes

Since in this case of study geotechnical properties pose some uncertainties in the simulation, each significant parameter (i.e. the friction angle, the cohesion and the percent filled of the tension crack) has been varied systematically over its maximum credible range in order to determine its influence upon the factor of safety. The other parameters have remained constant. The results of the analysis are shown in Fig. 13.

The plot shows that the SF for toppling increases very quick when groundwater level falls and, as it is well known, does not depend on the shear strength on the sliding plane. Furthermore, SF only reaches values lower than 1 when more than 95% of the tension crack is filled with groundwater (i.e. when h_w is lower than 0.6 m).

For planar sliding, SF considerably increases with the friction angle and the cohesion, although the groundwater level exerts a greater influence. Assuming that the sliding of the block occurs along a failure surface involving the subunit T₁ and considering the upper and lower bound values of friction angle (ϕ from 31 to 32°) and cohesion (c from 0 to 18 kPa) (Table 1), we can calculate the envelope of the SF (plotted in light orange in Fig. 13). These values show that SF is less than 1 for h_w lengths lower than 1.1 m (i.e. more than 92% of the crack filled). Thus, the results indicate that when the perched groundwater level (GWL₂) increases, both the toppling and the sliding SF reduce. However, SF reaches values lower than 1 (unstable) firstly for planar sliding before doing so for toppling failure. Additionally, for h_w values up to 2.8 m (79.7% of the crack filled; Fig. 13), as the one recorded in borehole S-2', the safety factor is 1.2 for planar failure and 1.4 for topple. When the groundwater level falls under the contact between subunits T₁ and T₂, SF becomes infinity for toppling and 3.4 for planar sliding. Therefore, the stability analysis supports the sliding of rock blocks caused by ground water pressure as the main instability mechanism, although when high percentages of the tension crack are filled by groundwater (more than 95%), the blocks can also be affected by both toppling and sliding processes.
